UNDERWATER BRIDGE INSPECTION REPORT

STRUCTURE NO. 9517

SOUTH CHANNEL OF THE ST. LOUIS RIVER

DISTRICT 1 - CARLTON COUNTY, CITY OF CLOQUET

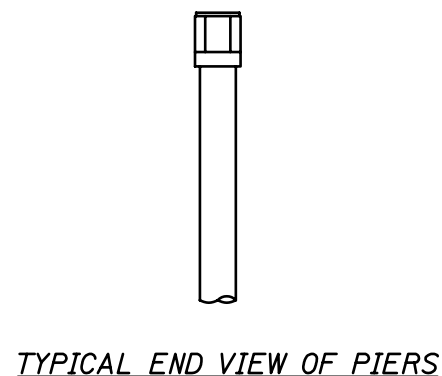
- 1 The channel bottom material consisted of 1- to 3-foot-diameter riprap with no probe rod penetration.
- 2 The steel pipe piles exhibited minor coating failure and up to 1/2-inch-diameter rust nodules over 5 to 10 percent of the surface area with no related section loss.
- 3 A minor accumulation of 4-inch-diameter and smaller timber debris was observed on the channel bottom at the upstream ends of both piers.
- 4 An 8-inch-diameter log was observed on the channel bottom.
- 5 A 6-inch-diameter log was observed on the channel bottom.

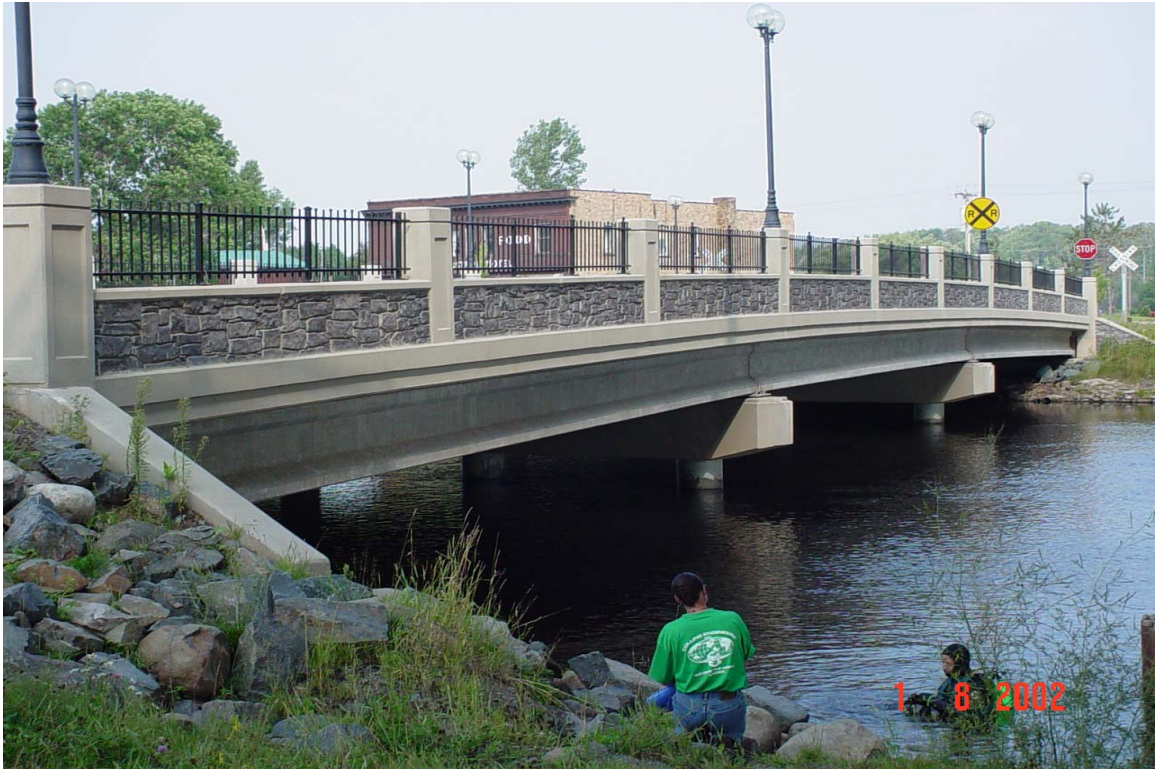
Photograph 1. Overall View of the Structure, Looking Northwest.
